# Rain Erosion Maps for Wind Turbines Based on Geographical Locations: A Case Study in Ireland and Britain

Article in *Journal of Bio- and Tribo-Corrosion* · March 2021

DOI: 10.1007/s40735-021-00472-0

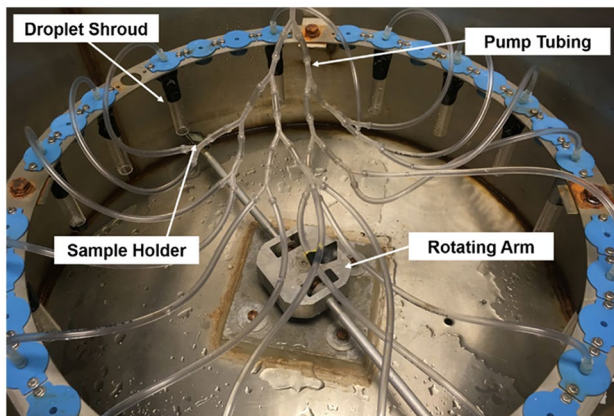
**Fig. 1** Whirling arm rain erosion rig

Upon the completion of this map an experimental process in the Tribology laboratory at the University of Strathclyde was carried out to relate rainfall across the country to the degradation of wind turbine blades. There are many different ways to test for rain erosion [8]; however, the test method used for this case study is the whirling arm setup [9]. This consists of a large chamber with induced rainfall from hypodermic needles; in the centre of the chamber is a rotating arm which holds the material sample at the end. Adjusting the rotational speed of the spinning arm will adjust the impact velocity the sample encounters with the water droplet. The experimental setup can be seen in Fig. 1 and a schematic is shown in Fig. 2.

All the variables which were kept constant including impact velocity, temperature and rainfall were all calibrated before the experimental campaign began. The impact velocity was calibrated using light transducer which was held close to the rotating shaft where a thin reflective strip was placed. A light source was focused onto the shaft and the transducer would give an electrical output when the light was reflected from the reflective strip each time it would rotate. The rain fall was calibrated by running the rain system for five hours and the water tank which feeds the rig was weighed periodically every 30 min to calculate the water consumed and hence the rainfall rate. The pump used was a peristaltic pump which proved to be extremely reliable and hence outputted 50 mm/h every 30 min. The temperature inside the rig was also measured and kept at  $29^\circ \text{C}$ , a temperature calibration test was carried out during the calibration of the rainfall where the temperature was measured using a probe inside the chamber and a reading was taken every 30 min for the five hours and the temperature only fluctuated  $\pm 1^\circ \text{C}$ .

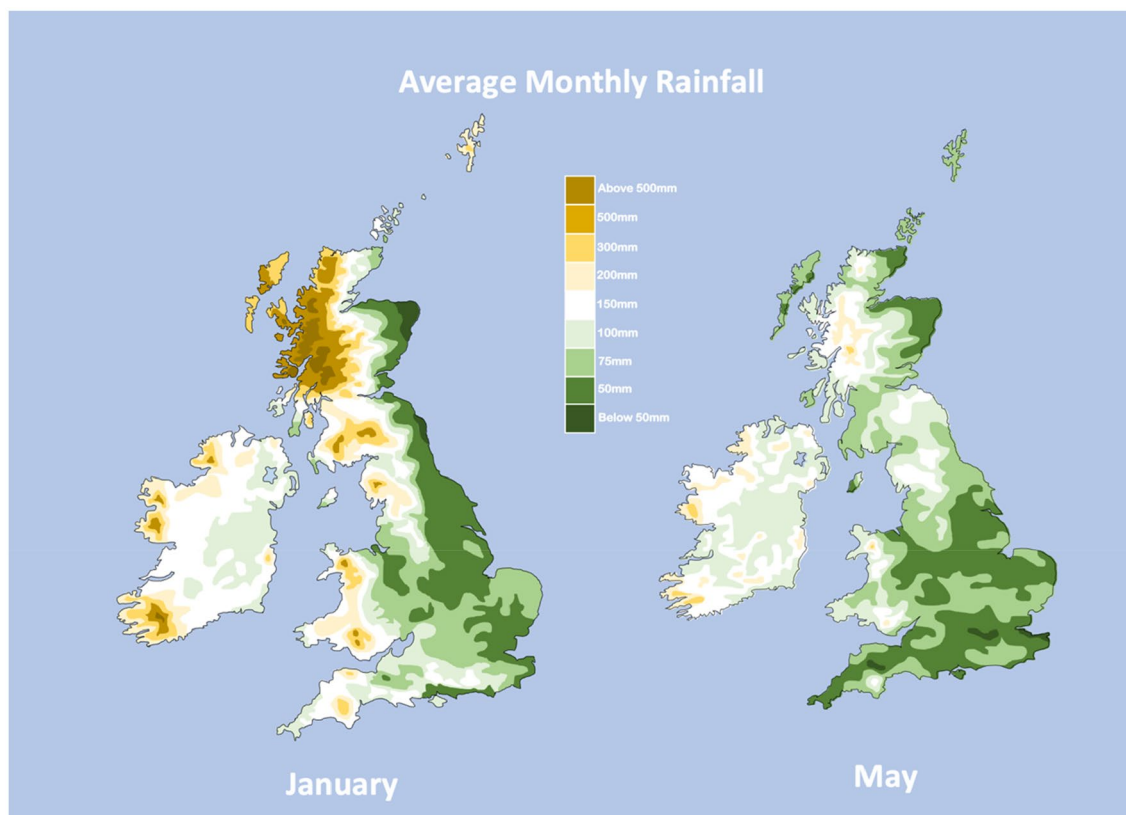
**Fig. 3** The average rainfall in the months of January and May

The procedure began by collating data from the Met office and Irish weather data. With this data an average rainfall map over the last 20 years was created. It should be noted that the turbine blades will inevitably experience varying rainfall rates throughout the year, which will, in turn, result in varying erosion rates. To map this phenomenon, the months of highest and lowest rainfall were chosen which were January and May, respectively. Showing the two extremes of rainfall months will provide more insight than a yearly average and

allow for contrast to be observed between the 2 months. The result of this can be seen in Fig. 3.

The construction of the rainfall map (Fig. 3) allows the setup for the experiment to be finalised. The key to the map displays: Below 50 mm, 50 mm, 75 mm, 100 mm, 150 mm, 200 mm, 300 mm, 500 mm and above 500 mm. The rainfall rate of the whirling arm rig is 50 mm/h therefore for the time each sample exposed to rain erosion can be determined, this is.

The rainfall mostly averages between 50 and 500 mm of rain with some few areas showing more extreme rain. It is clear that the month of May experiences considerably less rain as it shows highs of 300 mm whereas this rate is fairly common in January. The areas of intensity are very similar in both months with the west coast of Scotland showing a high rainfall and also the west coast of Ireland, predominantly the south west coast of Ireland displaying very heavy rainfall. These are historically harsher climates due to the prominent westerly wind from the Atlantic [12]. This leads to further erosion as the largest windfarms are located in these areas due to the increased power output from the consistent wind [13]. This is a very common trade-off when building a windfarm as the conditions that yield the most power generation are also the conditions which deteriorate the turbine blades most rapidly, therefore the life of the turbine blade will be reduced [14].

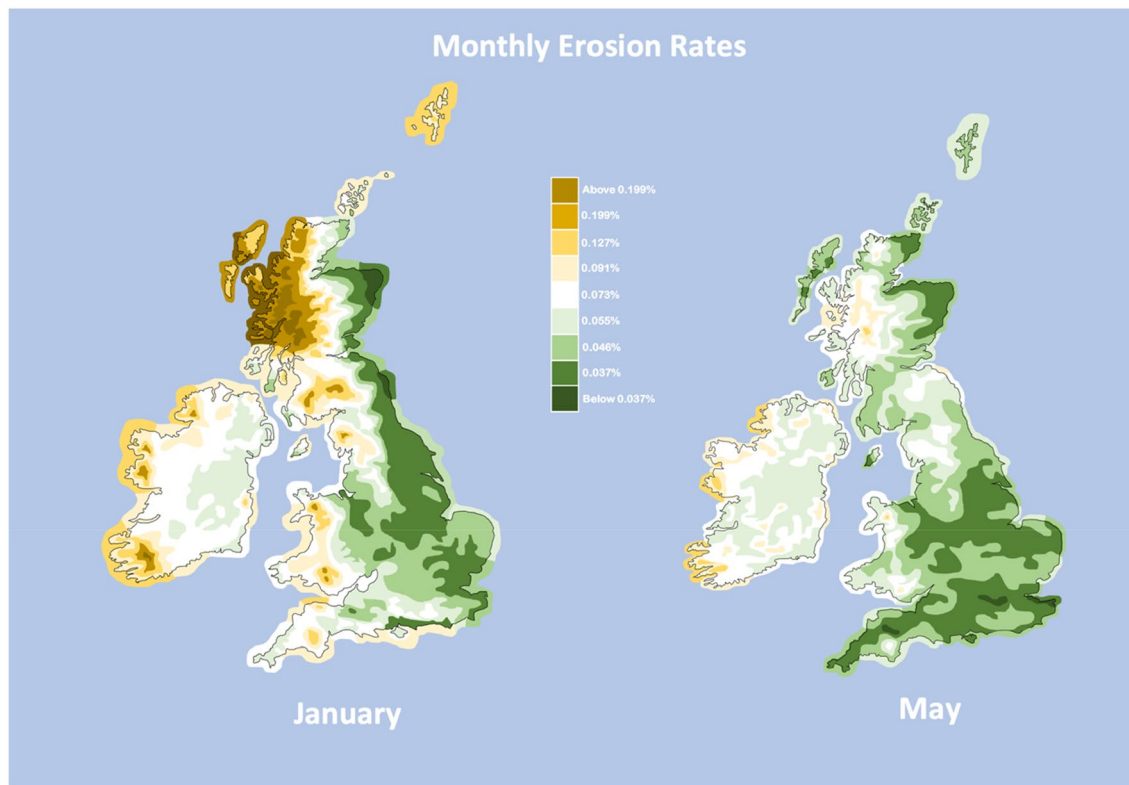
**Fig. 4** The monthly erosion rates in January and May

Once the rainfall maps were created the link between rainfall rate and erosion rate could be made as mentioned previously. This allowed the same maps to be created with

the key displaying erosion as a percentage mass loss of a theoretical turbine blade.

The results showed a maximum mass loss of 0.199% which relates to 500 mm of rainfall and a minimum mass loss of 0.037% which relates to 50 mm of rainfall. Although mass loss is not the most precise measurement for erosion when compared to imaging samples and identifying gauges, cracks and loss of material [18, 19]; it does allow for a broader comparison between samples.

The rainfall data is only available on land, therefore there was no offshore rain data to compare to the offshore erosion data. From the experiments using saltwater (3.5% saline solution) there was a higher mass loss at the higher exposure times compared to the neutral water tests. To compensate for this a border of approximately 10 miles was created offshore around the islands and assumed to be one grade above the adjacent onshore erosion rate. For example, the mainland of Shetland displayed an erosion of 0.046% mass loss therefore a 10-mile boundary off the coast of Shetland was created displaying the next grade up in the key which is an erosion of 0.055% mass loss. This is displayed in Fig. 4.

It is clear that the general trend consists of greater erosion in the west coast of both the UK and The Republic of Ireland with the highest erosion areas being the north west of Scotland where the land tends to be at a higher elevation and also the south west of Ireland where there is no protection from the prevailing wind over the Atlantic.

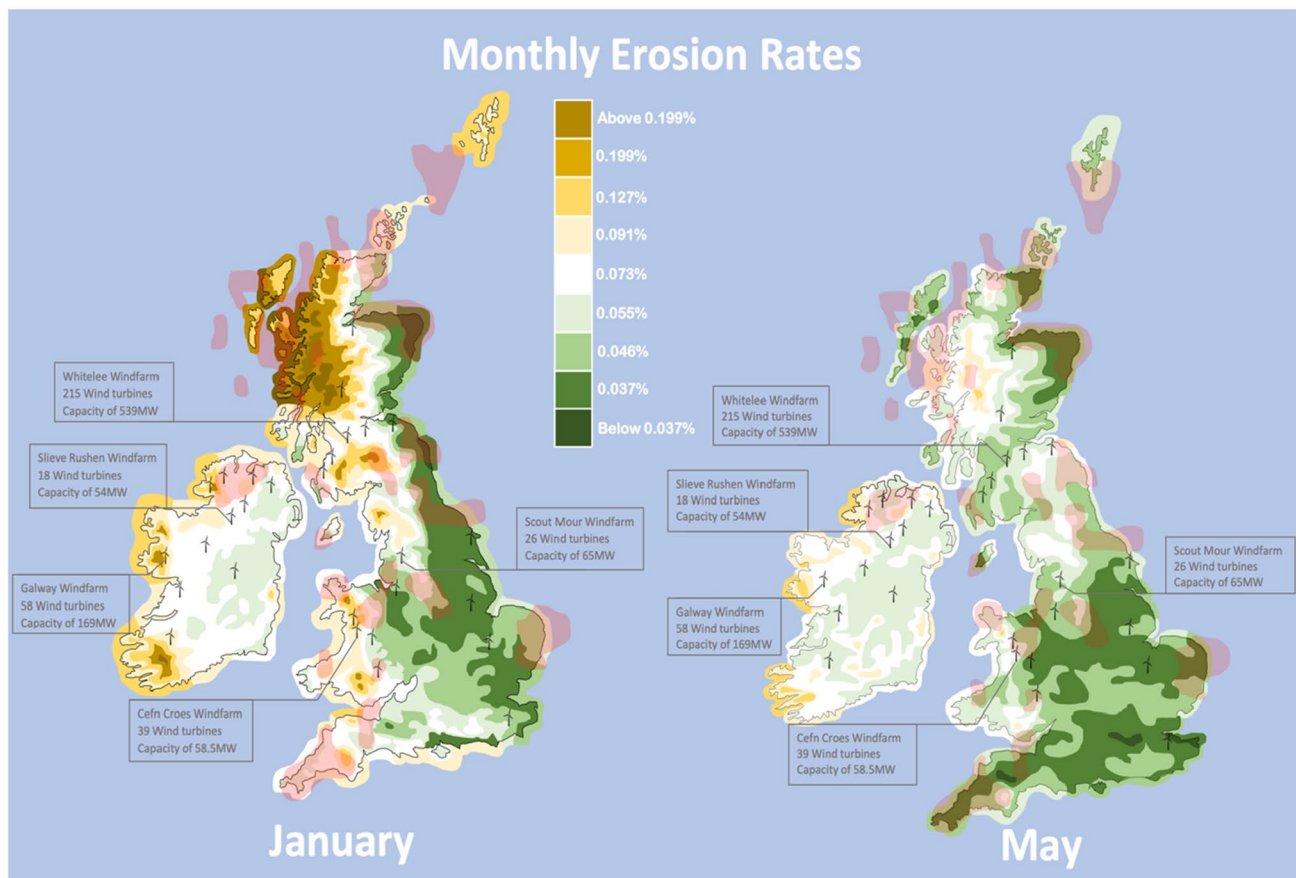
**Fig. 5** The monthly erosion rates in January and May with overlays of major wind turbine farms and areas of frequent hail

Construction of these maps now allows for further comparison to be made including locations of major wind farms and also areas of high hail rates which is displayed in Fig. 5. Even though the rainfall rate maps cover all precipitation, it is important to locate areas of high hail impact as these tribological actions can be detrimental to its structural integrity. Although the probability of hail striking wind turbine blades is very low and the damage would be difficult to ascertain, and it could possibly be masked as the outcome of heavy rainfall erosion, the implications of hail impacts have been proven experimentally to cause substantial damage. In a study looking into ballistic ice impacts, it was shown that the impact would delaminate and crack the composite material [24]. This would not only create a weak point in the blade structure itself but also create an initiation site for rain erosion to occur and for crack propagation into the structure of the blade. The areas of frequent hail are shown in Fig. 5 as the red overlay, and from the maps it is clear that the west coast is more adversely affected by hail. Unfortunately, there was limited data on hail in The Republic of Ireland; therefore, assumptions on this issue for this area of the map need to be treated with caution.

Also superimposed onto the map in Fig. 5 is the locations of some large wind farms and the largest in Scotland, England, Ireland, Wales, Northern Ireland and The Republic of Ireland have been labelled [25]. This not only allows for a comparison between the size of the various windfarms in each region but also how adversely affected each one is by the climate and the subsequent erosion. Most of the windfarms are in compromising locations but, as discussed previously, this is a trade-off between greater access to consistent wind to the lifetime of the blades.

The locations of frequent hailstorms across the UK and the republic of Ireland could be considered stochastic, however, the locations of some major wind farms overlap with frequent hail; this can be seen predominantly in Northern Ireland. This overlap could potentially reduce the lifetime of the turbine blades at an increased rate due to more powerful impacts from hailstones.
